Sawkill Creek

Stream Corridor Assessment Report

Ulster County, NY

May 2007

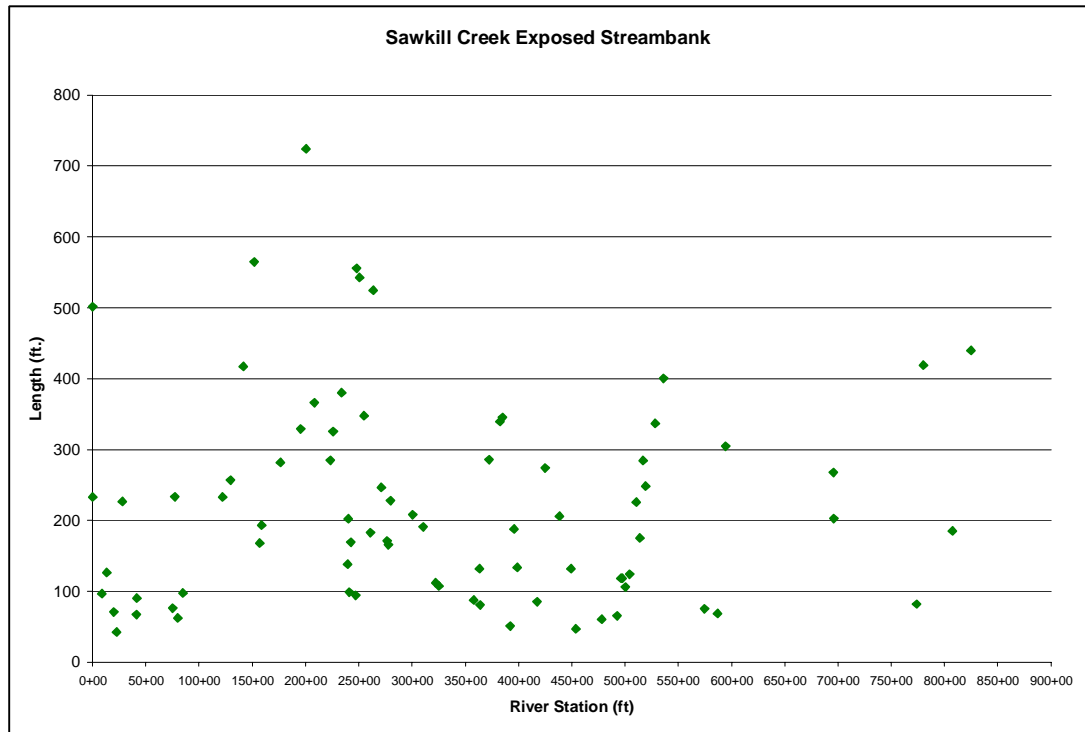
Figure 1. Length of exposed streambank measured along Sawkill Creek.

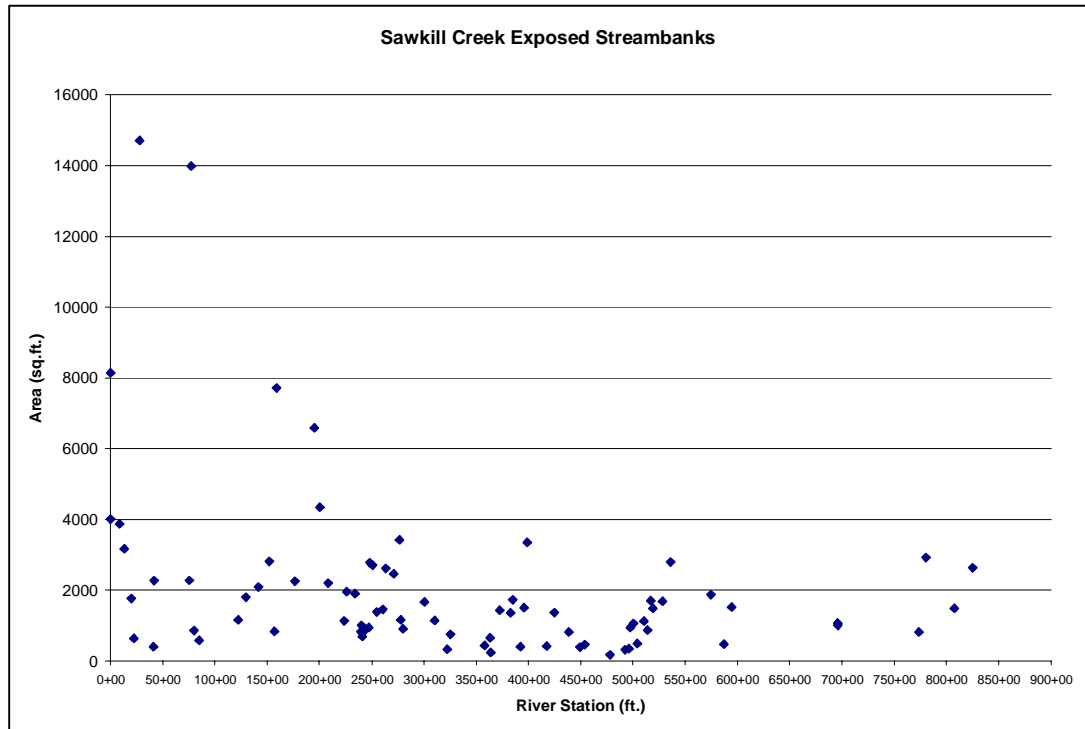
Figure 2. Areas of exposed streambank measured along Sawkill Creek.

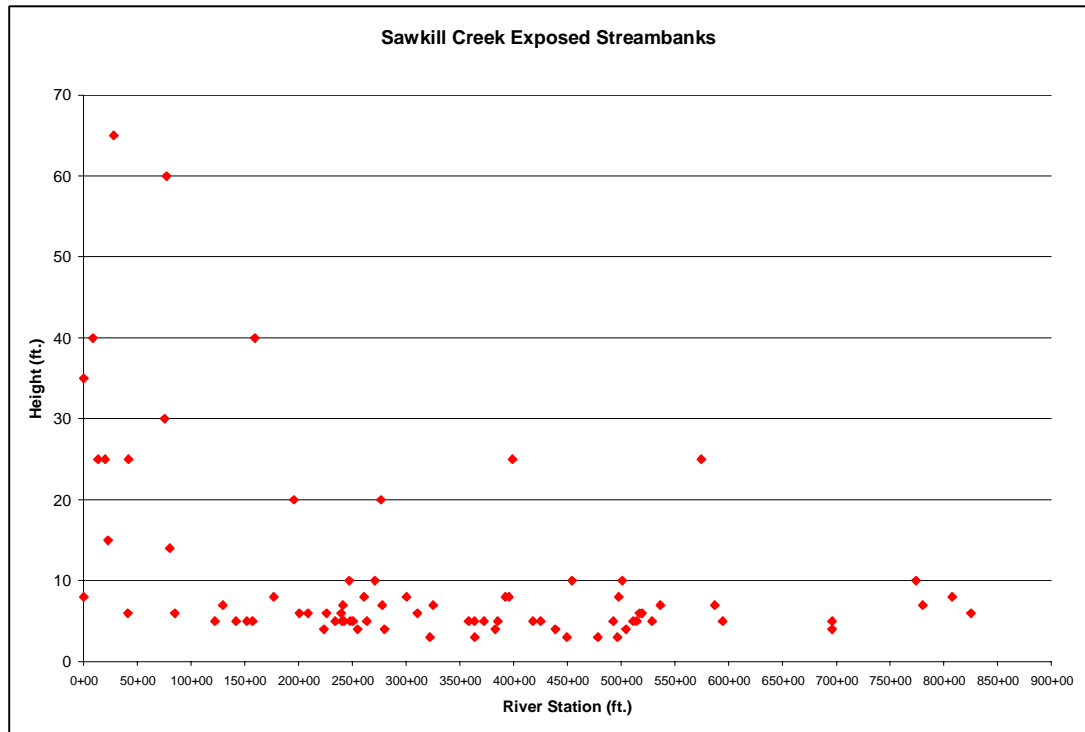
Figure 3. Height of exposed streambanks measured along Sawkill Creek.

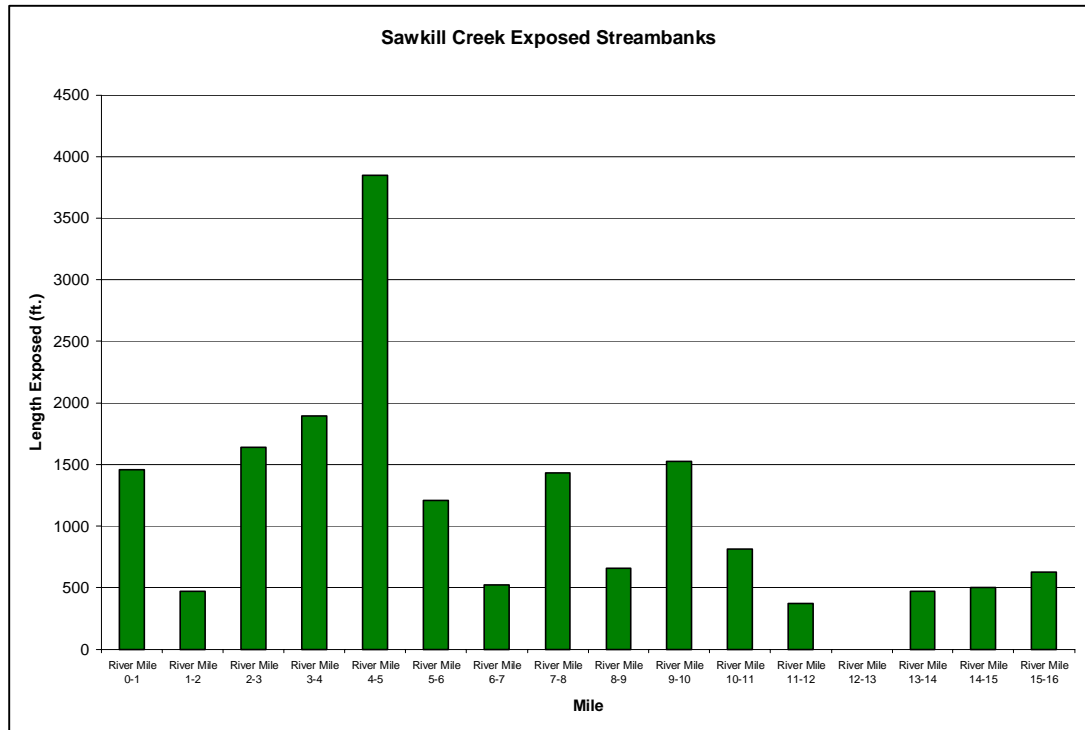
Frequency analysis of the erosion data shows a high density of erosion in the area between Stations 200+00 and 280+00 in River Mile 3-6. Eroded stream banks in the upper portion of the watershed were generally greater in height and with overall greater areas of soil exposure, potentially due to the confinement of the valley in the headwaters. Typically, this valley morphology generates the potential for large streambank failures through relatively small adjustments in stream channel alignment.

Figure 4. Length of exposed streambank on the Sawkill Creek expressed by River Mile.

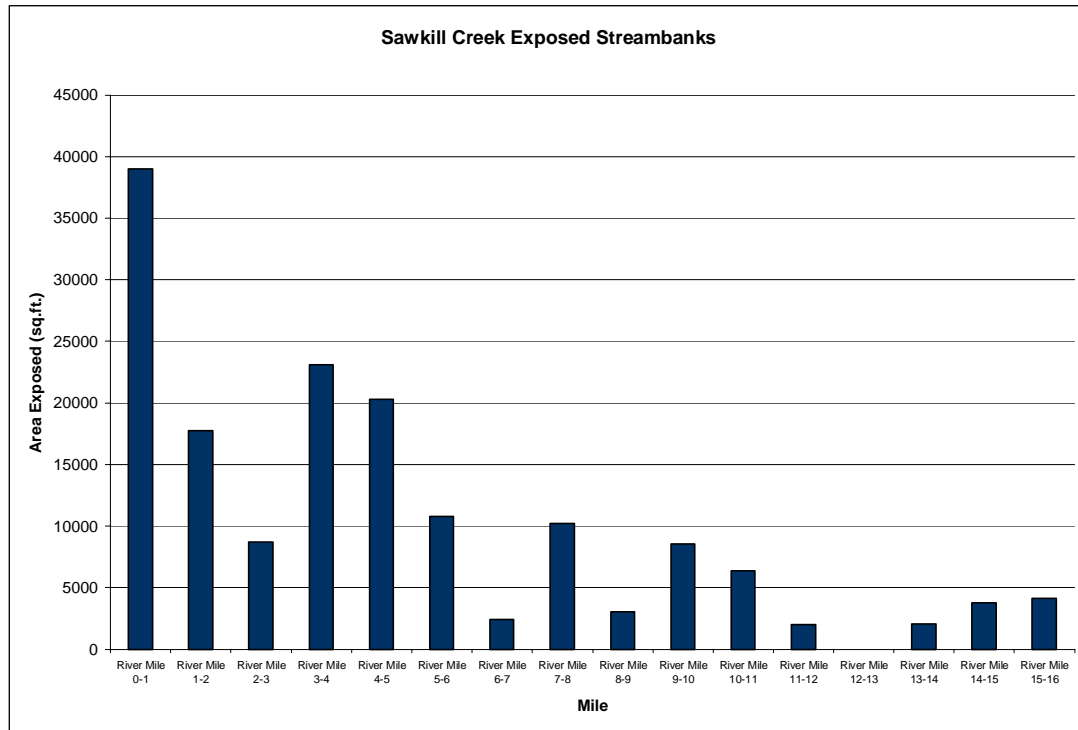
In order to initially prioritize reaches for future management and planning, stream reaches were sorted by total exposed area and total length, Table 2. River Mile 4-5 is ranked highest of the reaches with the longest length of eroded streambank, and third in eroded bank area. In theory, effective streambank stabilization and/or restoration within River Mile 4-5 could reduce the eroded length of streambank over the entire corridor by nearly 22% and reduce the exposed area of streambank by 13%.

Figure 5. Area of exposed streambank on the Sawkill Creek expressed by River Mile.

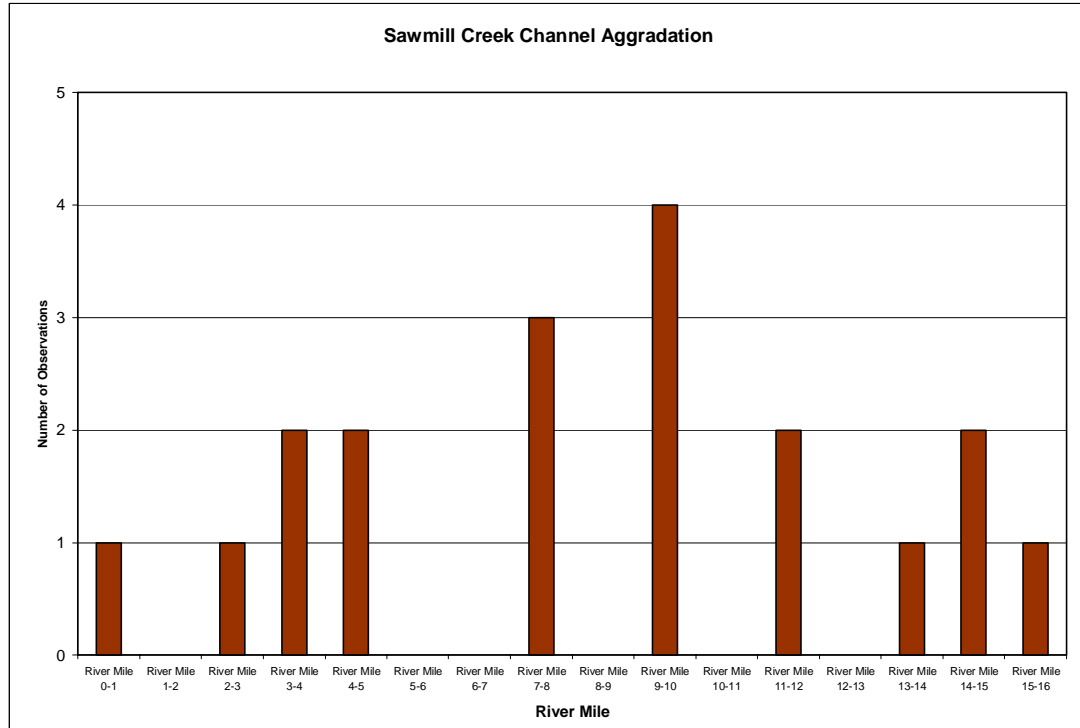
Signs of sedimentation were observed in nineteen (19) reaches of the Sawkill, typically in the form of sediment deposition or an aggrading channel bed. Figure 6 shows the instances of aggradation stratified by River Mile. The greatest number of observations was recorded in River Mile 9-10. River Mile 9-10 also contains excessive streambank erosion in the lower portion of the reach near John Joy Road Bridge. This area is discussed in detail in the Site Recommendations section of this report.

Figure 6. Instances of channel aggradation displayed by River Mile.

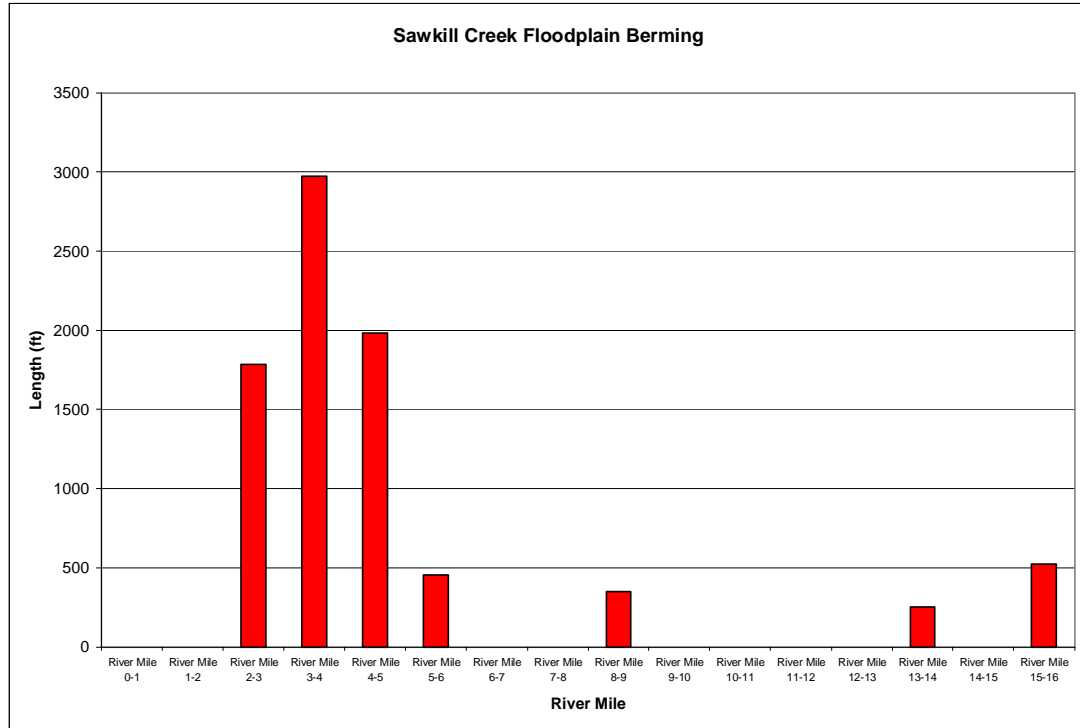
Most of the berms inventoried were discontinuous in length and varied in overall height. Variations in the elevations along the majority of the berms inventoried may allow floodwater to easily breach certain areas. Discontinuity may create abnormal divergence and convergence of floodwater and result in unpredictable floodplain deposition and scour. Additionally, the discontinuity may allow floodwater to flow behind the berms and prevent floodwater and ancillary drainage from flowing back into the stream channel.

Figure 7. Length of berms measured along the Sawkill Creek per River Mile.

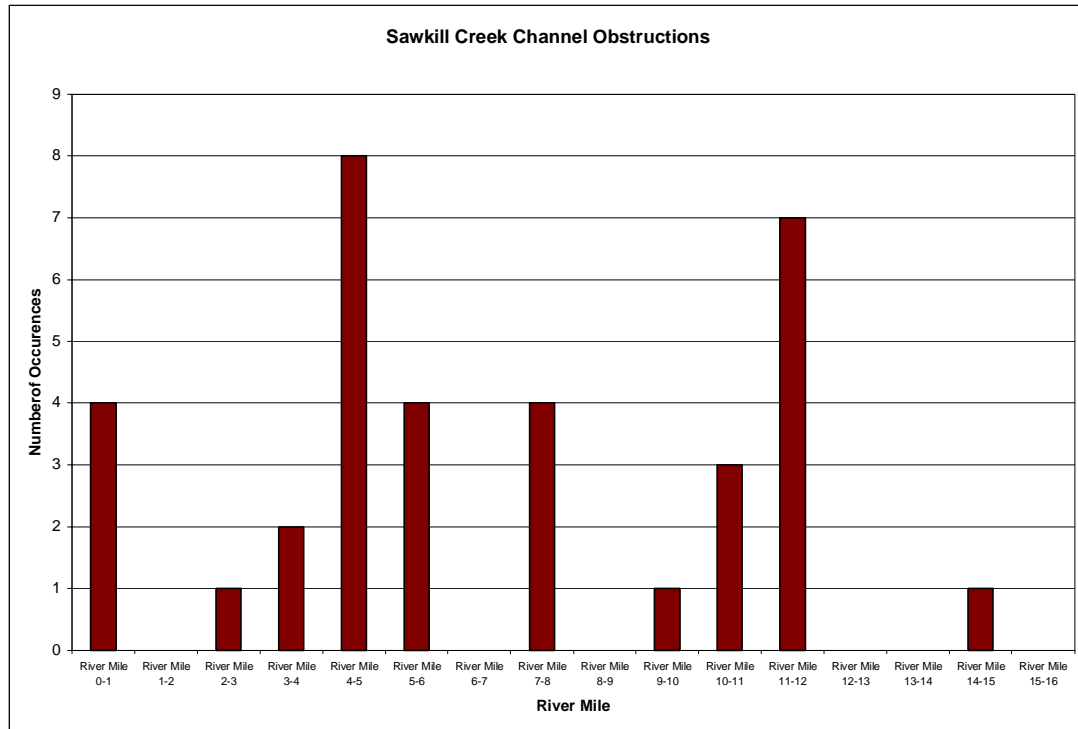
The inventories of the Sawkill identified thirty-five (35) debris jams, consisting of downed trees and plant materials, some including items such as tires and stone. Figure 8 displays the number of occurrences of debris within the delineated River Miles.

Figure 8. Instances of debris accumulation and channel obstructions inventoried along Sawkill Creek.

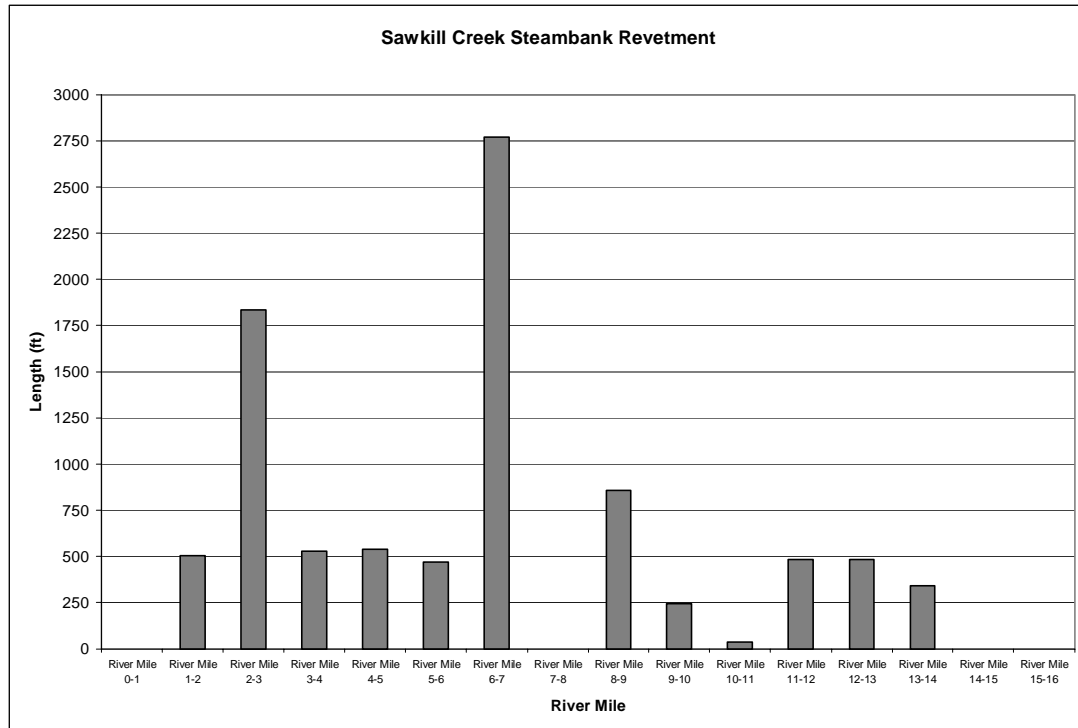
Figure 9. Streambank revetment inventoried along the Sawkill Creek by River Mile.

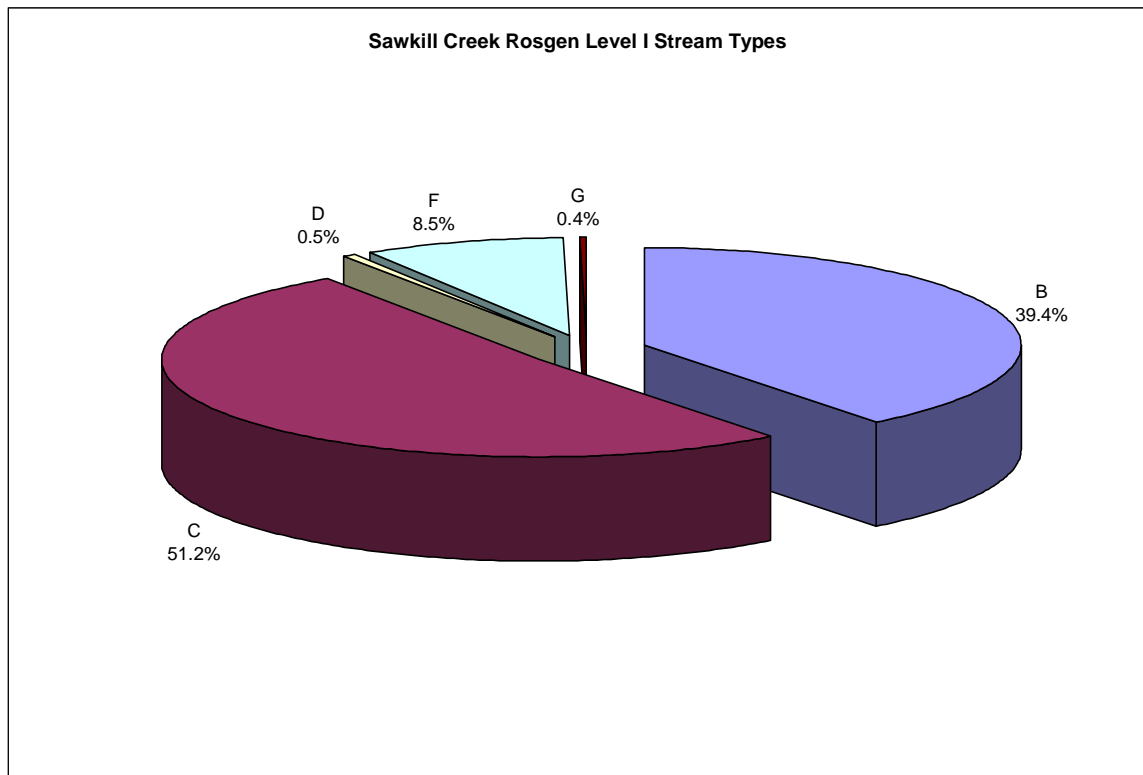
Figure 10. Rosgen Level I Stream Type Distribution for the Sawkill Creek.

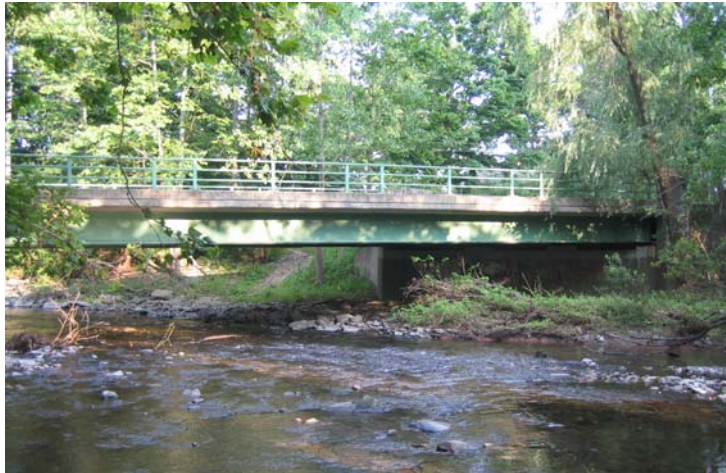
On numerous occasions, the county-owned and maintained bridge on John Joy Road has been inundated by storm flow and debris. This has required emergency response by the Town of Woodstock Highway Department to relieve debris blockages. Floodwater has damaged John Joy Road on several occasions, which has resulted in costly repairs. Streambank erosion and large accumulations of sediment and debris have been inventoried in the reach upstream of the bridge, which also suggests a backwater condition at the bridge.

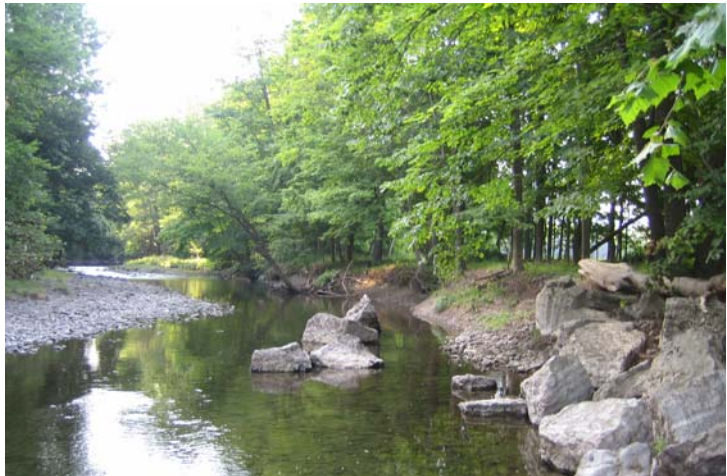
Several past attempts to stabilize sections of the streambank using riprap and large rock were noted upstream of the bridge. Currently, numerous pieces of riprap have become dislodged and are scattered along the channel bottom. The stream has flanked a section of the failed riprap that now extends into a portion of the active channel, creating a minor flow diversion.

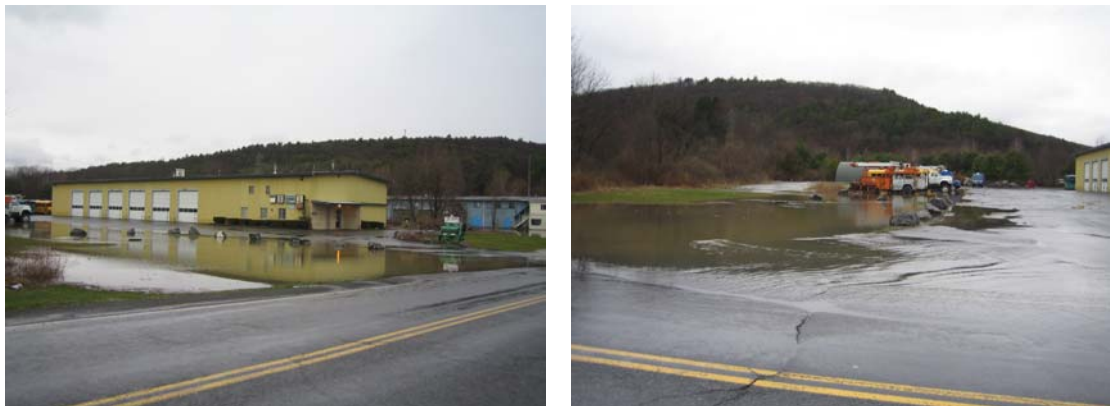
Flooding of the Heritage Energy and Eagle Diesel Power parking lots were observed on April 16, 2007 following a heavy rain event. During this event the Sawkill Creek did not crest the top of the bank, or result in flooding of the area. Flood water from the small unnamed tributary which flows east along the property owned by Eagle Diesel Power, was observed overtopping its banks and inundating the area west of Sawkill Road. This condition may aggravate and increase flooding of the area during periods where inundation occurs as the result of the Sawkill Creek flooding.
