Sawkill Creek

Stream Corridor Assessment Report

Ulster County, NY

May 2007

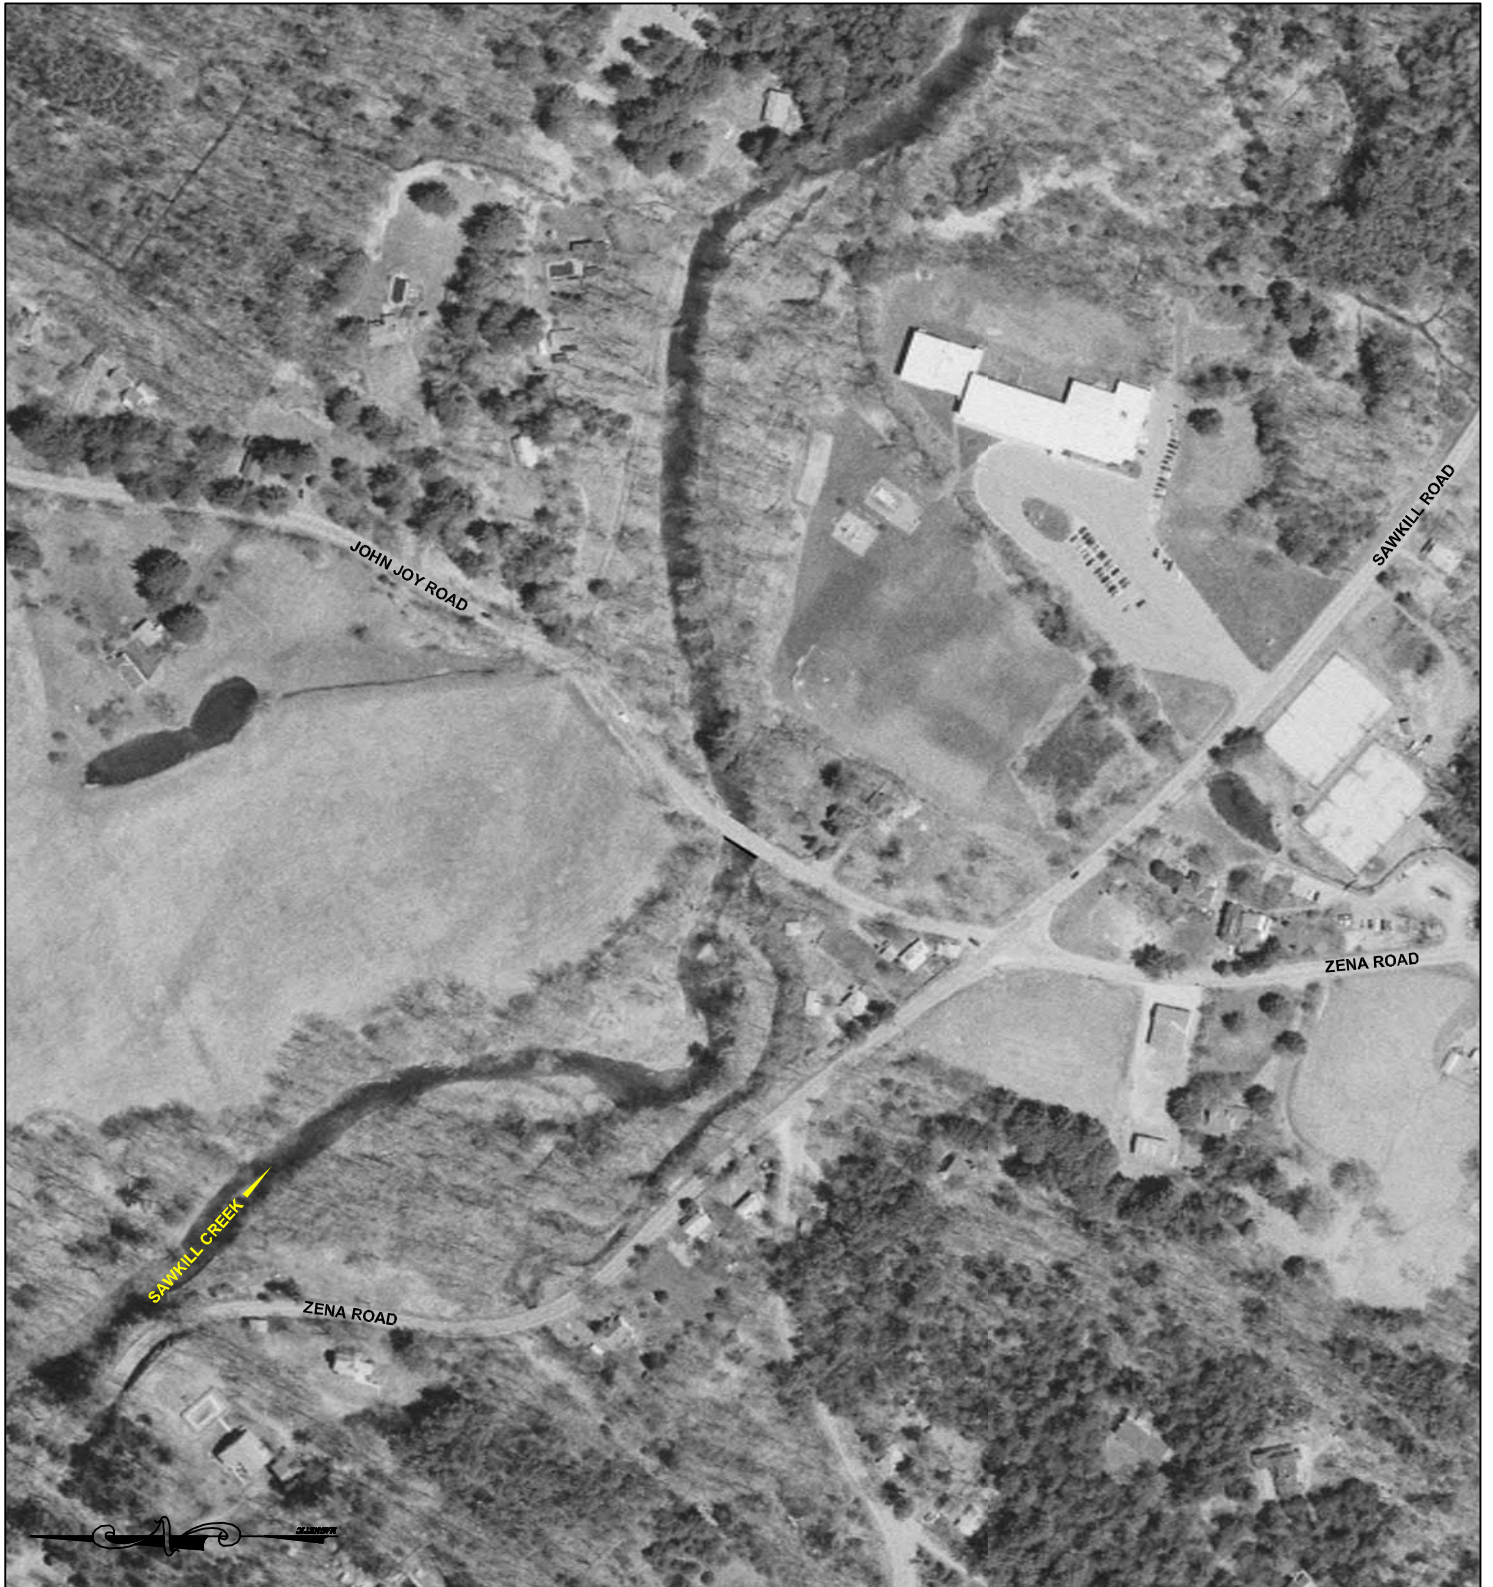
Figure 11: Sawkill Creek near John Joy Road.

On numerous occasions, the county-owned and maintained bridge on John Joy Road has been inundated by storm flow and debris. This has required emergency response by the Town of Woodstock Highway Department to relieve debris blockages. Floodwater has damaged John Joy Road on several occasions, which has resulted in costly repairs. Streambank erosion and large accumulations of sediment and debris have been inventoried in the reach upstream of the bridge, which also suggests a backwater condition at the bridge.

The reaches surrounding the bridge are Rosgen “C4” type stream channels dominated by center and side bar gravel formations. These formations display little vegetation and evidence of recent enlargement. Channel sediments consisted of gravel substrate with several instances of recent deposition. The area upstream of the bridge on John Joy Road contained several debris jams and numerous downed trees, which most likely instigate sedimentation and aggravate flooding. Several recent deposits of sand, gravel, and debris were observed throughout the wooded portions of the floodplain.

Extensive streambank erosion along several meander bends located upstream of the bridge were noted. Review of aerial imagery from 1995, 2001 and 2004 revealed moderate lateral migration upstream of the bridge. Lateral migration measured 30 and 40 feet demonstrating rates of erosion of 4.5 to 5 feet per year. Further streambank erosion threatens the stability of the confluence with the “Van Dale Road” tributary.

Several past attempts to stabilize sections of the streambank using riprap and large rock were noted upstream of the bridge. Currently, numerous pieces of riprap have become dislodged and are scattered along the channel bottom. The stream has flanked a section of the failed riprap that now extends into a portion of the active channel, creating a minor flow diversion.

The recurring problems with debris and sediment accumulation, bank scour, and erosion upstream of the John Joy Road Bridge should be further investigated to determine their causes. From this initial evaluation it is suspected that the following factors compound these problems:

- The inadequate cumulative hydraulic capacity of the bridge structure and floodplain may result in backwater (and a subsequent accumulation of gravel and debris) during high flow events.
- The sediment accumulation causes a reduction in mean stream-channel depth, upstream from the bridge area, which results in both lower flow velocity and reduced sediment transport capacity.
- Erosion both in the reach and from upstream areas contributes to an excessive, supply of sediment and large woody debris.
- The natural tendency of the stream channel to migrate both laterally and down valley will intensify both sediment and debris supply to the site.

Development of a hydraulic model of the bridge and surrounding reach is recommended. Standard models (e.g. HEC RAS) can provide the ability to analyze hydraulic requirements necessary to reduce floodwater surface elevations and improve water and sediment conveyance through bridge and floodplain. The developed model could be used to efficiently evaluate multiple scenarios and would be required to analytically justify any alternatives.

The potential alternative exists to raise the elevation of John Joy Road on the northern portion of the bridge approach in attempt to alleviate flooding of the roadway and to lessen damage during moderate flood events. Drainage under the road could be designed to allow passage of floodwater under the roadway onto the downstream floodplain area. Initial observations of the current profile of John Joy Road, the elevation of the bridge approach, and the elevations of the upstream and downstream floodplain appear to make this a feasible option. An adequately engineered design, one which takes into account the hydrology of the Sawkill Creek at this point and the hydraulics of both the bridge and surrounding floodplain area, would be required to determine the targeted flood flow and elevations used for the design in order to assure adequate protection of the roadway and upstream and downstream floodplain areas.

It is recommended that any direct attempt to alleviate flooding at the bridge should include stream restoration upstream of the bridge. This reach is an ideal candidate for “natural channel design” techniques to improve sediment transport, reduce local streambank erosion and sediment yield, and strengthen the confluence with “Van Dale Road” tributary, maintaining and possibly improving the habitat and natural characteristics of the stream channel.

If the problems causing the debris and sediment accumulation can not be addressed due to funding or time constraints, this area should receive limited routine maintenance to prevent future blockage of the bridge opening. If this is required, a management strategy should be developed for the area allowing controlled access by equipment to maintain proper stream channel alignment, dimensions, and slope that would not create additional impacts to the area nor neighboring stream reaches.

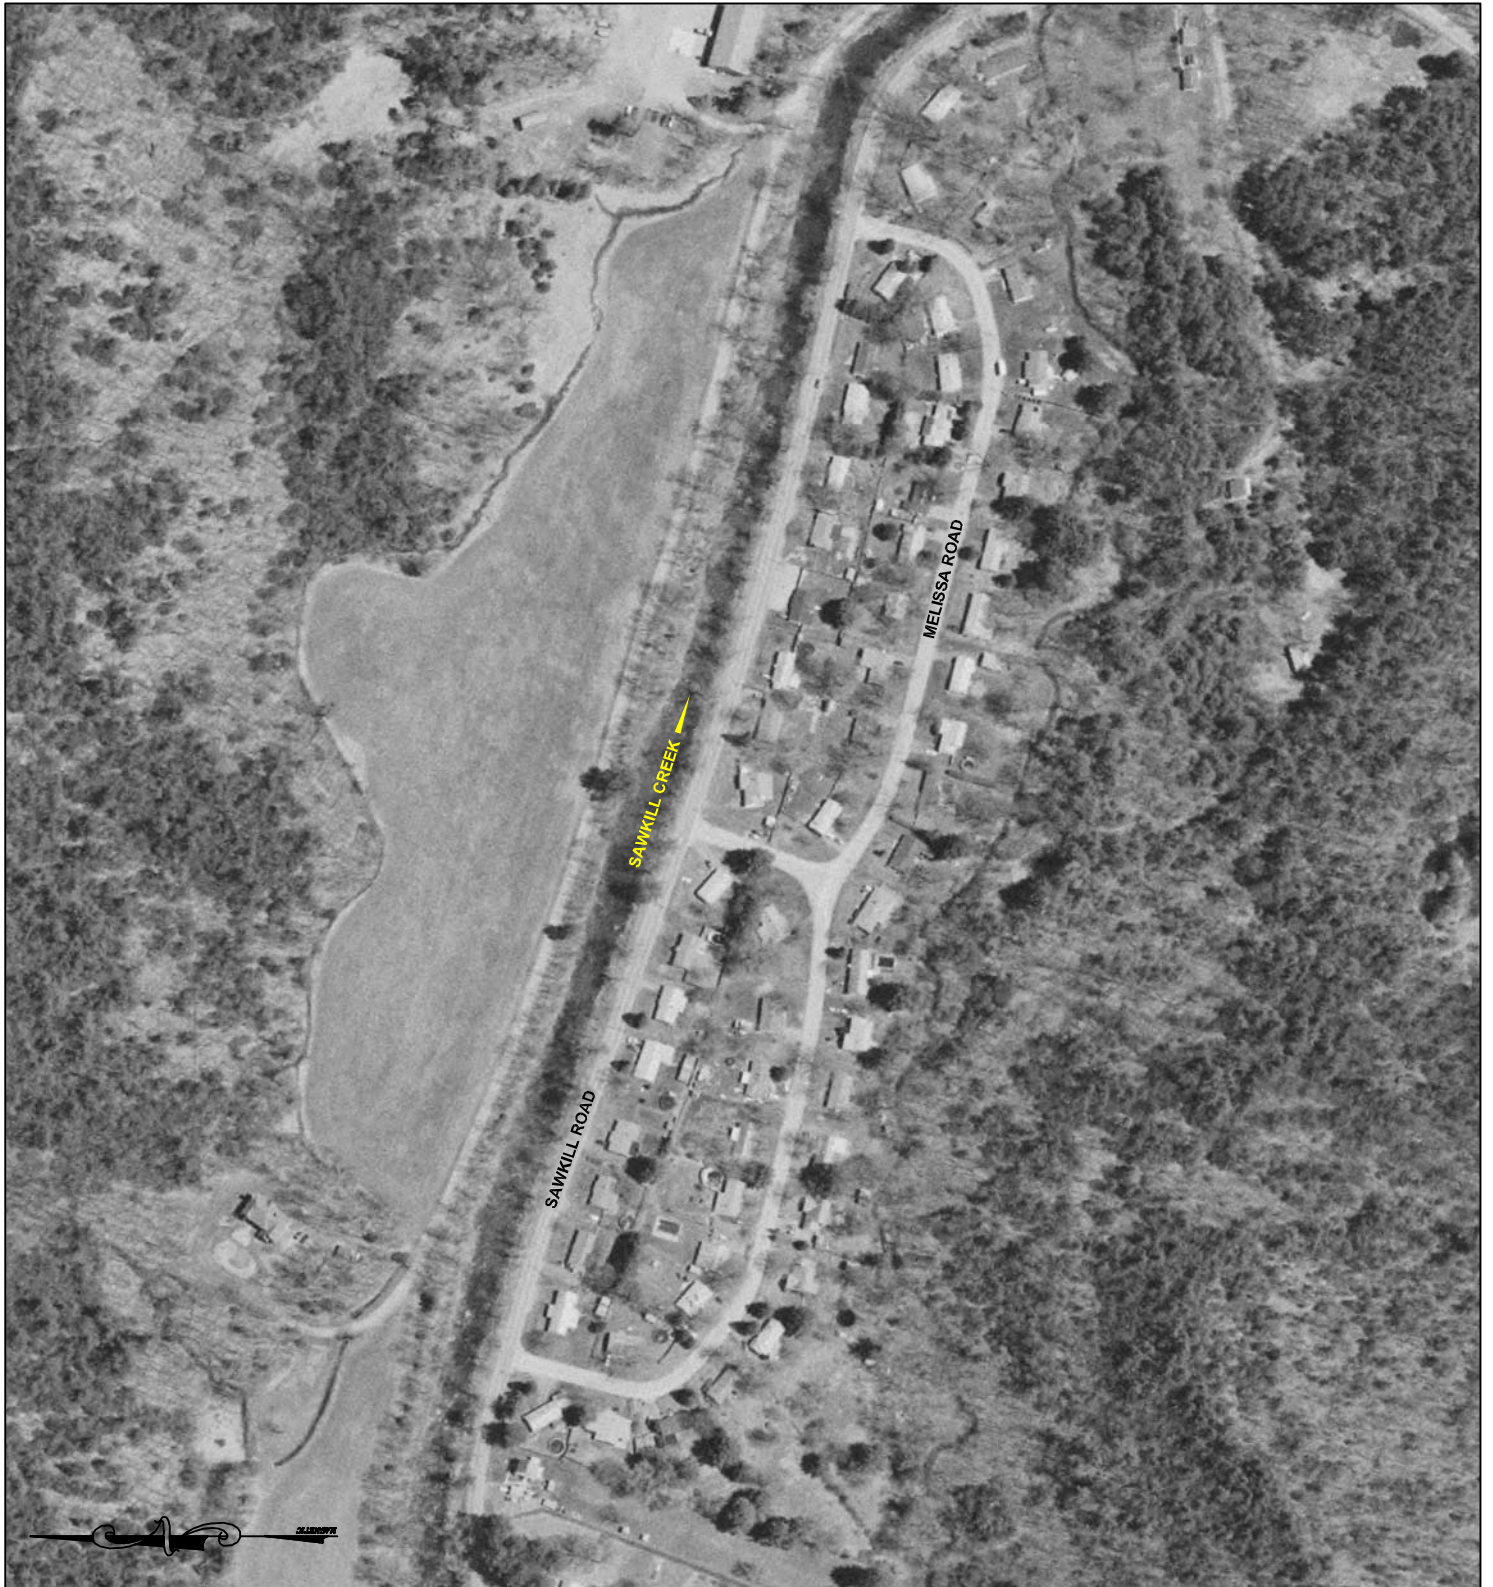
Figure 12: Sawkill Creek near Sweet Meadows.

The stream channel through this section of Sawkill Creek is trapezoidal in shape and classifies as an F stream type. The reach is exceptionally straight, having extremely low sinuosity. It is apparent that some form of channel dredging and straightening has occurred in the past. Although this type of stream channel is not typically the natural stable form found in this setting, it does appear to be relatively stable. The north floodplain, which does not contain any residential or commercial structures, appeared to be higher in elevation than the south floodplain where Sawkill Road and the Sweet Meadows development exist.

Both right and left streambanks appeared generally stable. Moderate vegetative growth was present along both streambanks, and although the width of the vegetated buffer was relatively narrow, it did appear that it added to the overall stability of the streambanks. Review of aerial imagery from 1995, 2001, and 2004 did not reveal any noticeable lateral migration or erosion of the Sawkill Creek.

A large bedrock shelf acts as a waterfall at the lower extents of the reach providing both lateral stability and grade control for the area. A small unnamed tributary flows behind the residences of Sweet Meadows. Erosion was present within this channel and evidence of channel incision of between one and three feet was observed.

It is likely that several factors combine to aggravate the flooding problem through Sweet Meadows. These factors include: the general location of the residences and roadway relative to the stream channel and floodplain, the magnitude and rapid flooding associated with the Sawkill Creek in this area, and the amplified flooding resulting from the tributary and the stormwater collection system in the area.

The stormwater drainage network in the Sweet Meadows development and along Sawkill Road may exacerbate flooding in instances where runoff within the area cannot drain properly. Although not assessed as part of this study, it is possible that the discharge pipes of the drainage network are submerged during periods of elevated flow in both the Sawkill Creek and the tributary. This situation could lead to the reduction in the volume of stormwater exiting the site during periods of elevated water surface elevations in the Sawkill Creek and tributary.

A review of the existing stormwater drainage network within the Sweet Meadows development should be conducted. The review and/or assessment should determine: the locations and sizes of catch basins and subsurface piping, the locations of the stormwater outfalls to both the Sawkill Creek and the tributary and their respective elevations relative to each stream channel, and estimated water surface elevation during flood stage. In addition, the capacity of the system should be determined in relation to outfall of the system during various flood stages.

Once the review of the system is complete, recommendations should be compiled for possible upgrades to the stormwater system to alleviate flooding, prevent backflow from the Sawkill Creek and the tributary, and improve overall stormwater drainage and/or storage.

habitat modifications, regulatory approvals, and community support. Options for mitigation include: Community or government buyout of flooded residential areas; Lowering of the base elevation of the stream channel, as outlined by the ACOE, to provide increased channel capacity and floodwater conveyance; Lowering the elevation of the north floodplain to provide increased floodplain capacity.

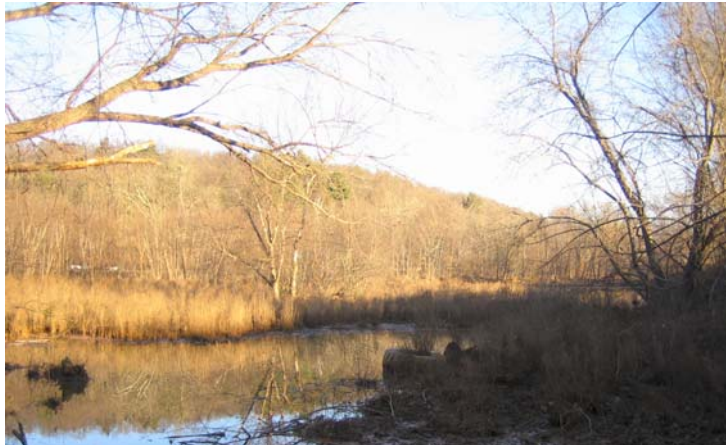
The project advisory group and representatives from the Town of Ulster selected a reach located at the confluence of the Sawkill and Esopus Creeks (in the Town of Ulster) for further evaluation. A private landowner, the Floodplain Coordinator for the Towns of Kingston and Ulster, and representatives of both the Sawkill Watershed Alliance and Integrated River Solutions

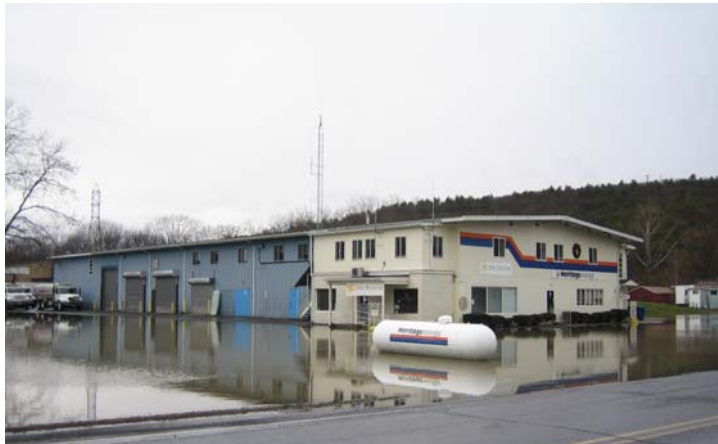
The Floodplain Coordinator informed the group that on several occasions the parking lot of Heritage Energy, a local heating oil business, has been flooded. Although this typically occurs only during large storm events, it was not believed that the actual building or ancillary structures were affected. It was added that several berms located along the floodplain had been recently removed by

Heritage Energy. There is a possibility the berms were originally installed to protect the area from flooding, but actually prevented stormwater and flow from exiting the area and increased the amount of water around the building.

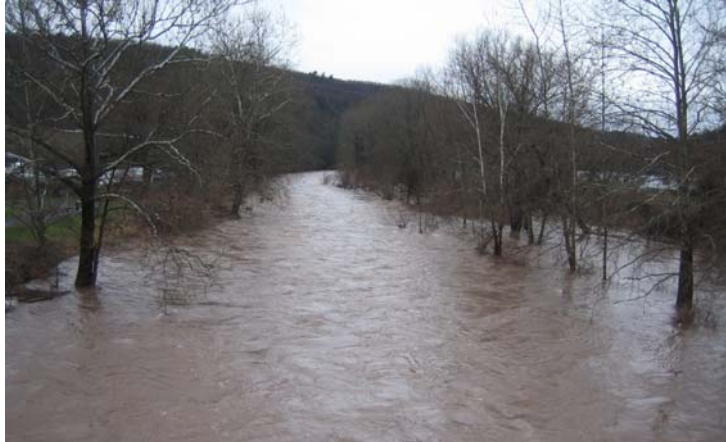
The frequency and extent of flooding in this particular area generally depends on amount of precipitation, the timing of flood peaks between the Sawkill and Esopus Creeks, and local obstructions in the channel and floodplain in the area of the bridge structures. The most significant flooding in this area of the Sawkill Creek would generally occur when large floods in both systems peak simultaneously

at the confluence area as was the case in April 2005. Although a solution to mitigate flooding in this area would entail detailed analysis of the area, which is beyond the scope of this study, several general recommendations based on the need for future assessment and evaluations were developed.

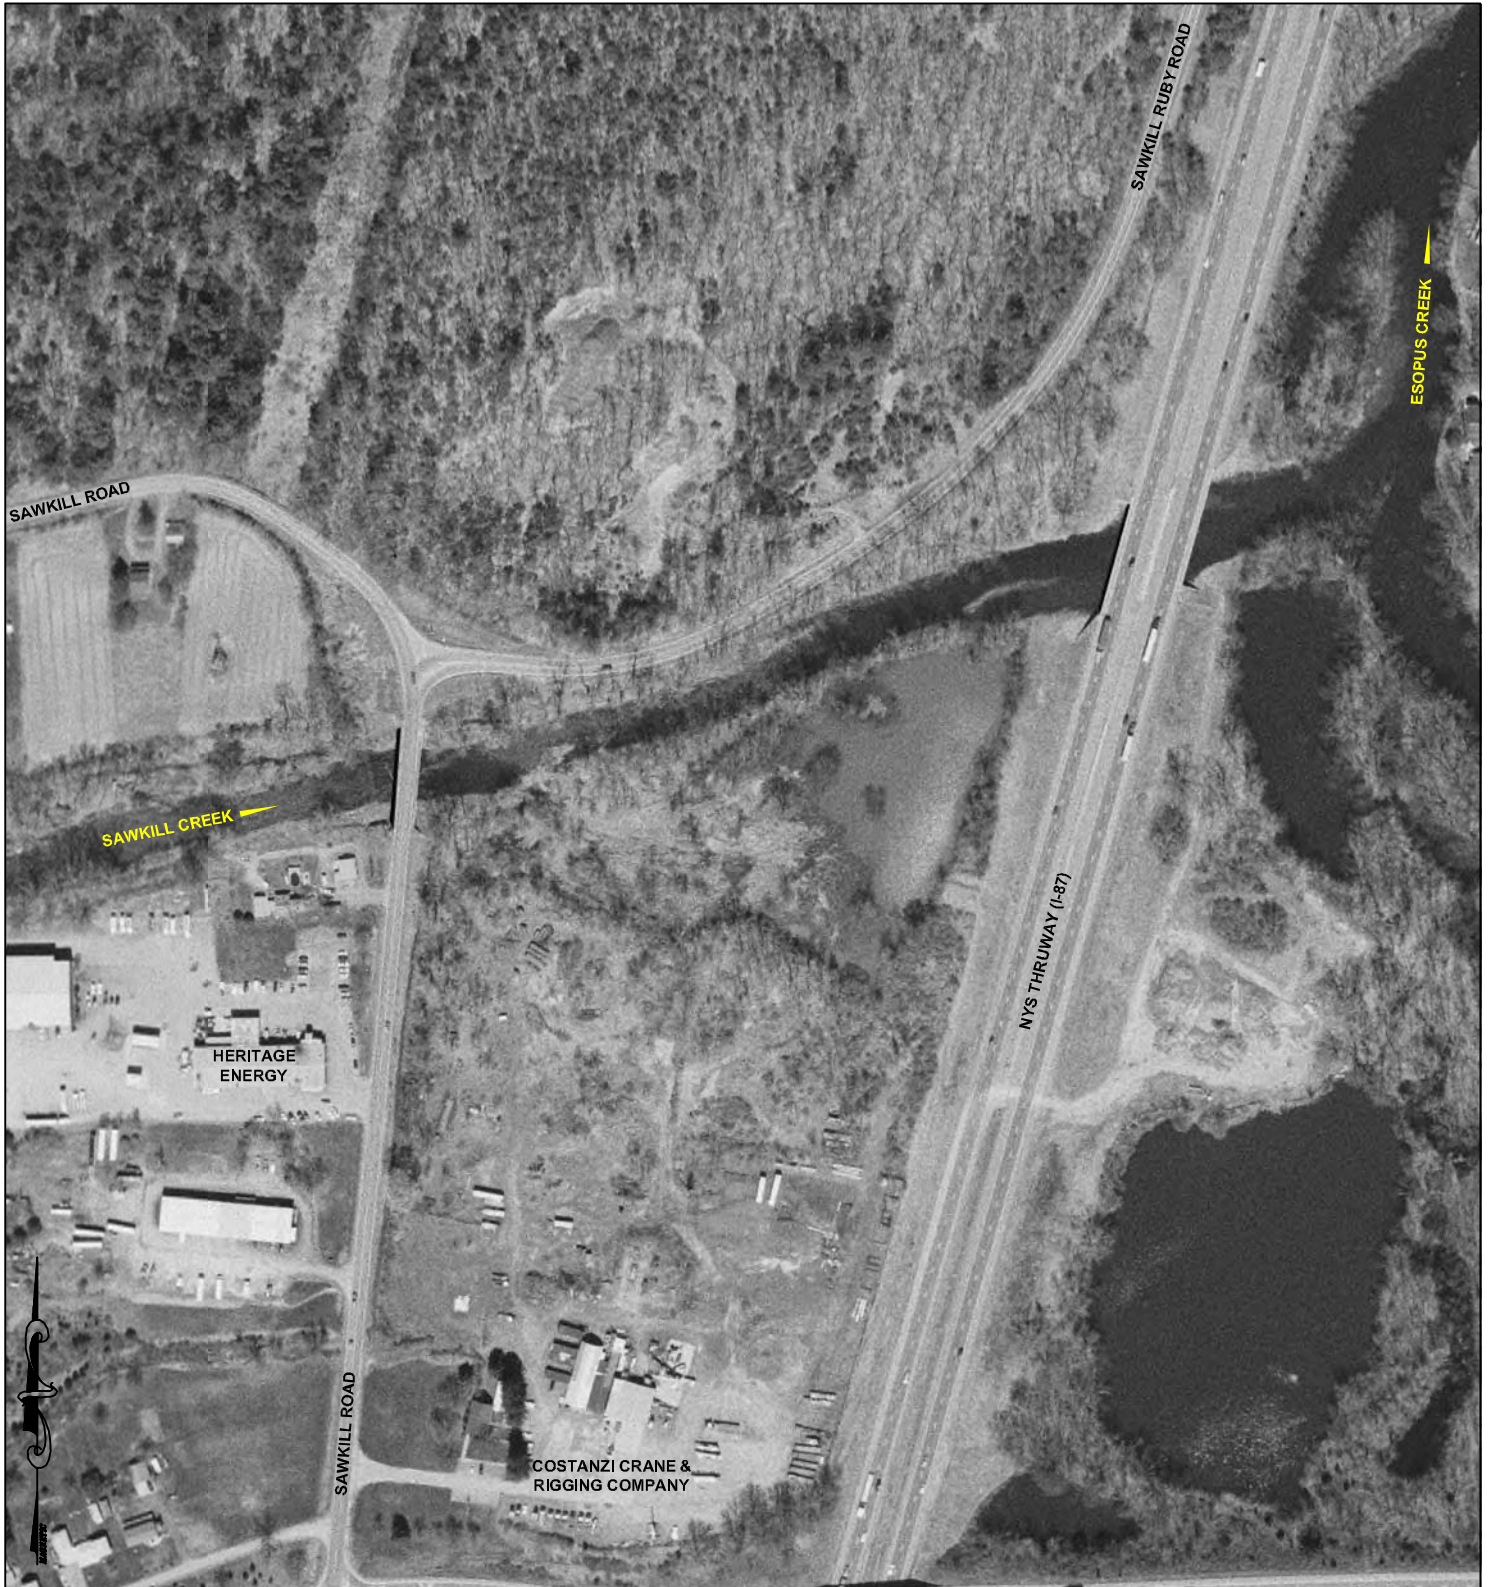
Figure 13: Sawkill Creek near confluence with Esopus Creek.

The southern floodplain, downstream of the Sawkill Road Bridge, remains mostly vegetated and includes a large wetland area and 1.8 acre pond. This area is included within the 100-year flood boundary and provides a significant amount of flood storage for both the Sawkill Creek, as well as the Esopus Creek during large flood events. The Constanzi Crane Company utilizes a portion of the area (lower lot) for equipment storage and parking.

Modification that would result in a decrease in flood storage capability of this area should be avoided. In addition, opportunities may exist to enhance this area for increased levels of floodwater storage, as well as improve habitat benefits.
